PHOTOGRAPHIC INTELLIGENCE REPORT

INSTRUMENTATION SITE 2 AND

SELECTED TRIAD FACILITIES

SARY SHAGAN MISSILE TEST CENTER, USSR

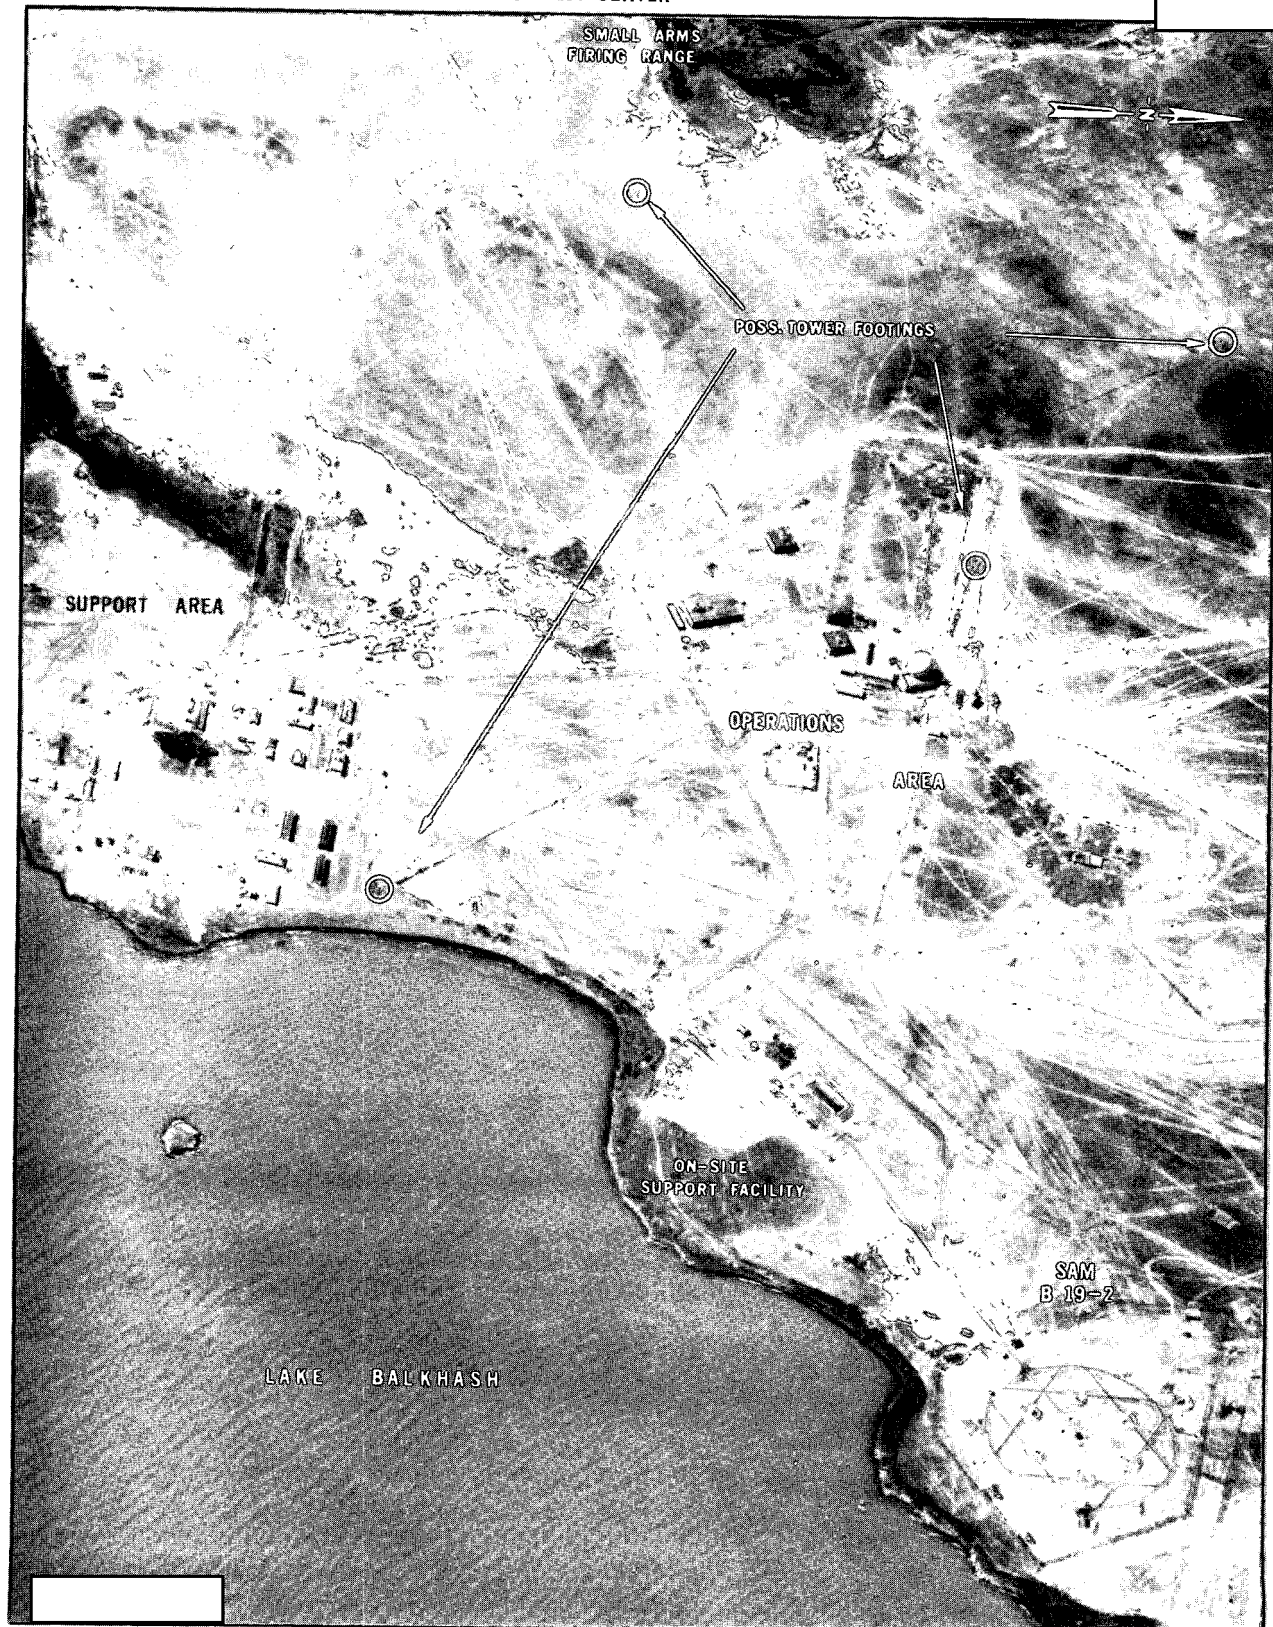
FIGURE 3

INSTRUMENTATION SITE 2 SARY SHAGAN MISSILE TEST CENTER

25X1
25X1
Three possible foundations for towers, similar to the one in Operations Area C, are positioned outside of the main operations area (Figure 3). An additional clearing containing a small, unidentified object has been present [redacted] approximately 700 feet west of the large triad building in Operations Area B.

25X1
A large, open trench had been excavated [redacted]. The trench extends south from the Launch Complex C Support Area along the main road to a point just north of the cooling towers in Operations Area A (Figure 3). At the end of the trench, a small, unidentified object was present. Due to its terminal proximity to the cooling towers, and from the appearance of a possible fluid discharge from the trench at that point, it is believed that the trench contains, or will contain, a water pipeline.

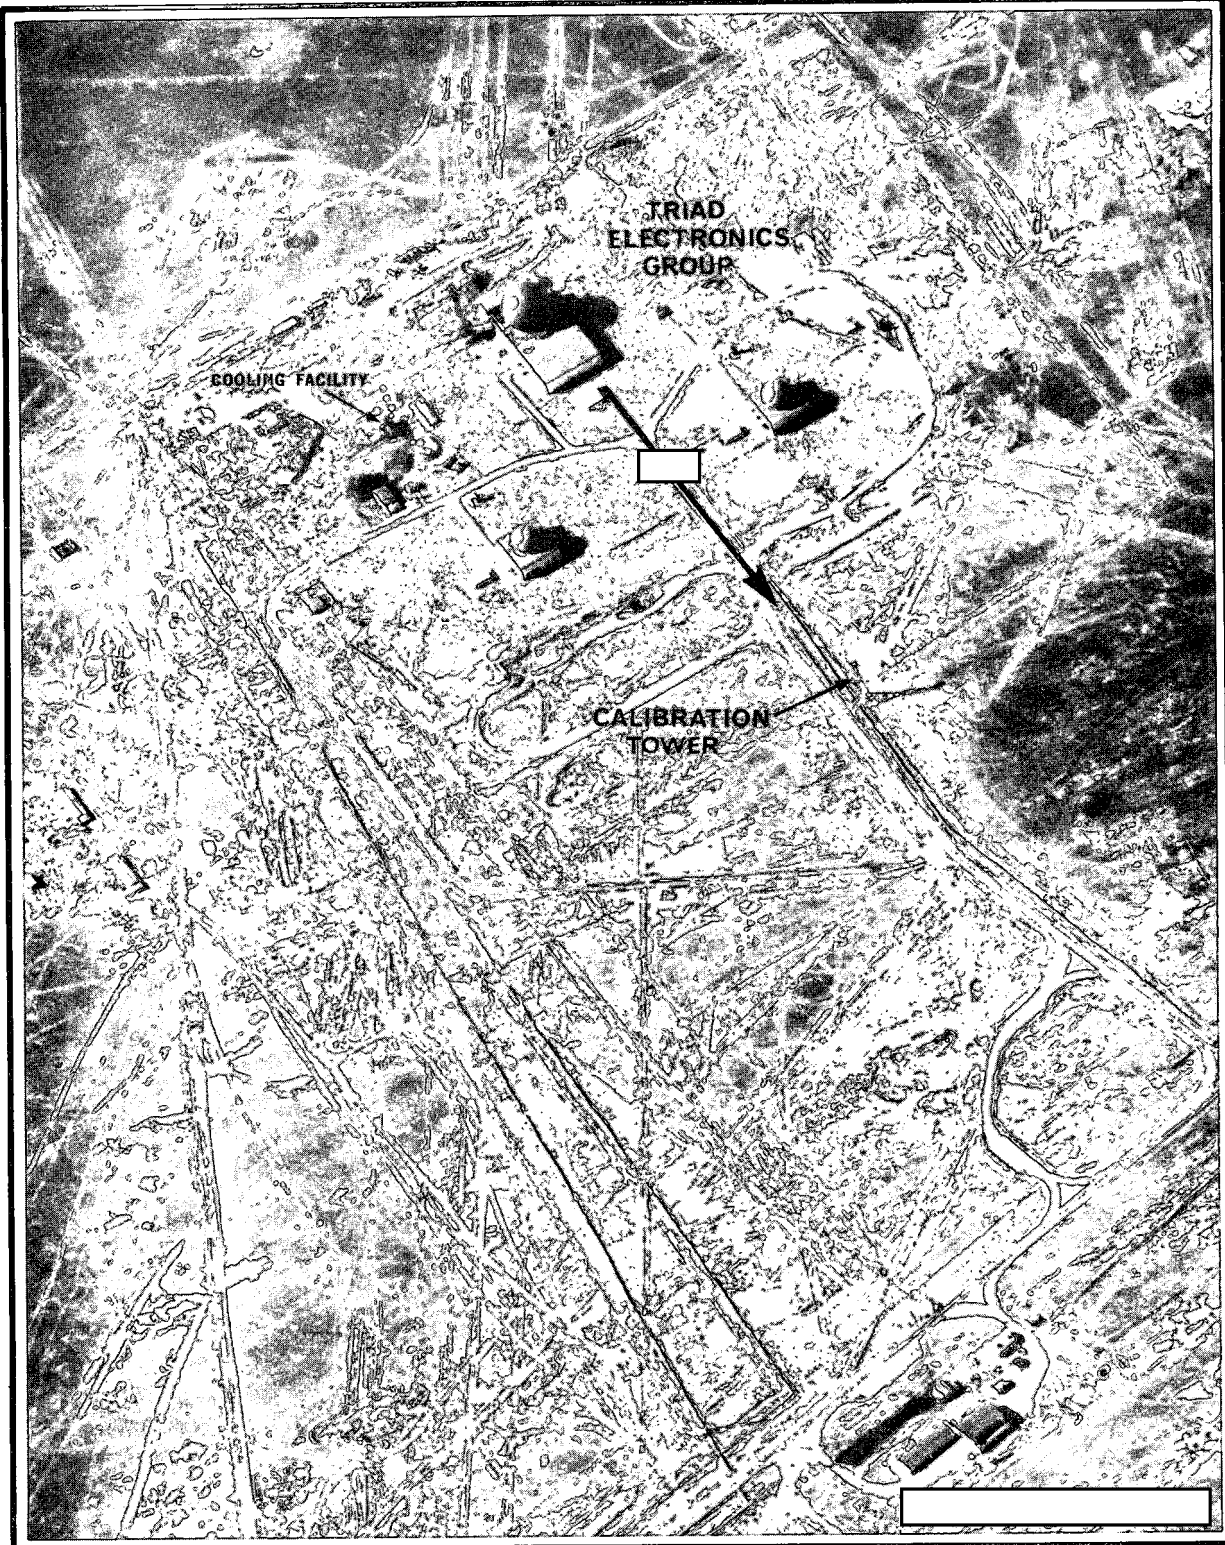
FIGURE 13

LAUNCH COMPLEX B, FACILITY C

As shown in Figure 2, four Triad Electronics Groups exist at the Sary Shagan Missile Test Center. The Triad at Launch Complex B (Facility C) is complete and probably operational, with environmental domes in place on each of the three buildings (Figure 13). Recent detailed reports provide information on this Triad Facility. Consequently, only the Triad groups at Instrumentation Sites 2 and 10, plus Site 13 will be described and compared.
